## **State of Art Review: Structural Health Monitoring, Retrofitting and Rehabilitation of Masonry Structures**

**Abstract:** Brick masonry being an oldest material for construction is widely used worldwide. Its low tensile strength and brittle nature has made it vulnerable under various loading. As unreinforced brick masonry doesn't show any ductility and becomes highly unsafe during earthquakes and therefore, Structural health monitoring has become necessary for old brick masonry heritage buildings having cultural value. A brief review is carried out on ways proposed by researchers to retrofit and restore brick masonry buildings by some of the techniques like tying, jacketing, shotcreting, introduction of fibre reinforced polymers (FRP), inserting meshes, base isolation etc., are more durable, popular and convenient in terms of application.

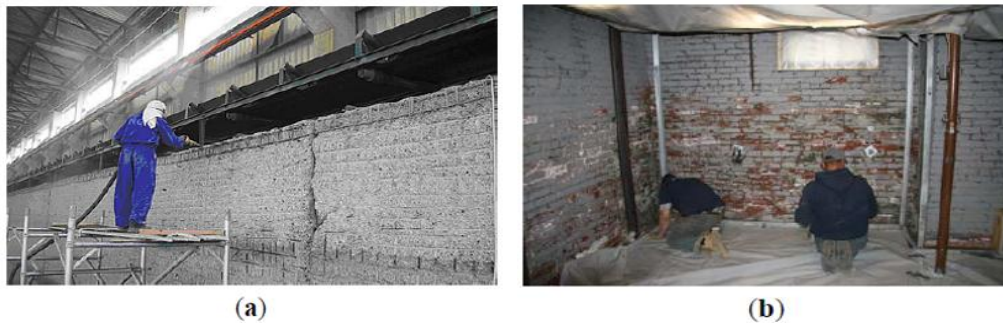
Fig.10. Shotcrete repair: (a) Concrete wall in factory; (b)Clay masonry walls (Augenti *et al* 2013).

Fibre Reinforced concrete (FRC) is considered as one of the oldest retrofitting material but most researched composite technology [13]. This technology is particularly most effective when substrate surface is rough after removal of loose and damaged portion or reinforcement is fully exposed and FRC is applied through shotcrete (see figure-10) and is made by adding randomly distributed fibres into a mortar or concrete. The effective application of FRC are such as tunnel lining, basement walls, slabs on grade etc.

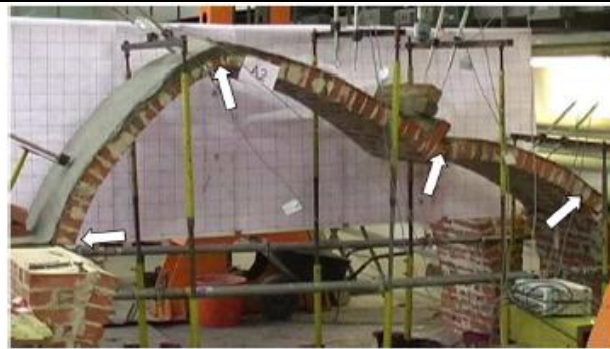
Fig.12. A<sub>2</sub> arch destruction scheme with marked hinging spots (Bednarzet *al* 2011).

[14] and [15] has carried out experiments on masonry arch by strengthening and retrofitting arch with sheets of CFRP's and GFRP's as shown in figure-11 & 12. The experimental work was then simulated the result of the numerical analysis validated the methodology adopted in this study. The result also confirmed that the applied retrofitting techniques significantly improved brick arch strengthened.

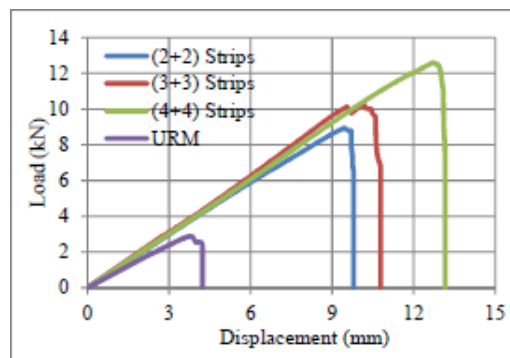
Fig.16. Load- displacement curve with volumetric ratio of 0.0072 of CFRP with varying number of strips (Parisiet al 2014).

[17] deals with the strengthening of masonry wall system carried out by using FRP (Fibre reinforced polymer). Aim of study was to find out the optimum quantity and placement of FRP for strengthening brick wall system which is done by testing ten masonry wallets under diagonal compression test (see fig-15). Response of masonry wallets with different volume and configuration of FRP strips were recorded. Carefully analysed results of experiment showed that for higher volumetric ratios as 0.0072, increasing number of strips of FRC has good effect on the ultimate strength and failure displacement. Reducing CFRP volume below certain level may not fruitful /suitable attempts as the width of CFRP will be reduced resulting in lower surface area of an individual strips (see fig-16).

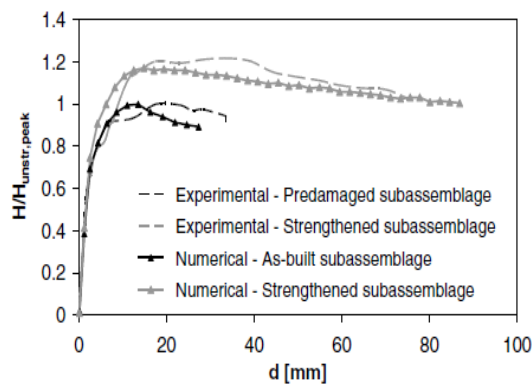
Fig.18. Comparison of numerical and experimental normalized curves (F Parisiet *al* 2011).

In [18] improvement of in-plane response of the walls with opening before and after external strengthening of spandrels with an inorganic matrix Grid (IMG) strengthening system has been studied. Recent seismic codes do not talk about assessment and strengthening of existing masonry spandrels panels by inorganic-matrix grid (IMG) composites. Experimental work was then simulated by using non-linear finite element analysis and micro-modelling technique of computation was adopted to verify the contribution of masonry constituents like masonry units, mortar, and IMG system constituents. The results of numerical as well as experimental analyses were compared for damage patterns and force-displacement curves (fig- 17&18).

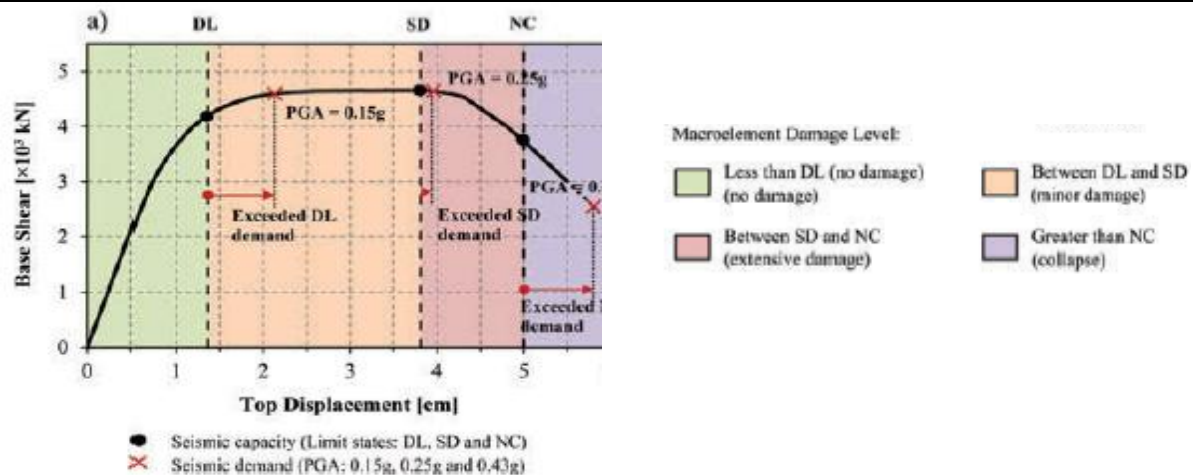
Fig.19. Capacity curve of the analysed building showing the corresponding limit states and the seismic demand displacements (khan *et al* 2017).

This paper aims on the application of natural rubber bearing base isolation technique for the seismic protection of masonry heritage buildings [19]. In this paper the opportunities which are available for the application of base isolation in case of seismic protection of unreinforced masonry (URM) structures which are important architectural heritage have been studied. A new methodology of URM buildings considering equivalent frame models (EFM) with plastic hinges is applied for the purpose of the study. Proper isolation devices are proposed on behalf of calculated approach for its selection which is based on Non-Linear static (pushover) analysis (fig-19) of such buildings and the desired level of protection, with reference to the code based damaged limit state.
